MOLD EVALUATION

**Quadruplex
208 and 210 Bates Avenue
St. Paul, MN 55108**

**AllPhase Companies, Incorporated
#1596-12S-U**

May 10, 2012

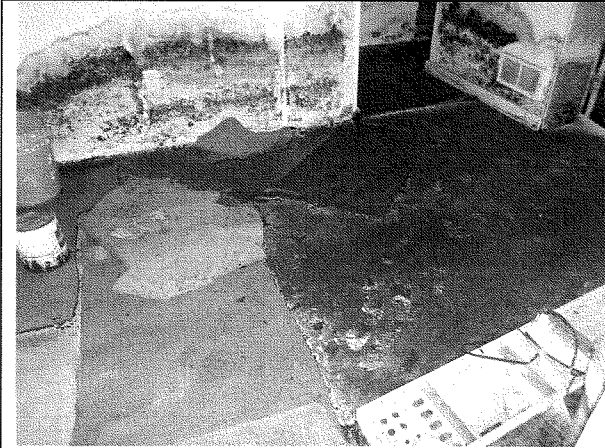
208 First Floor—kitchen: standing water on floors and saturated carpet plus mold were present on the kitchen floor and walls.

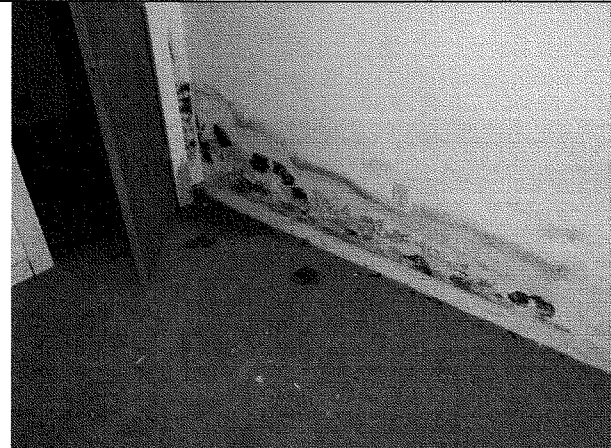
208 First Floor—SE-central room: saturated carpet and wet floors were present with mold located on the lower portion of the walls.

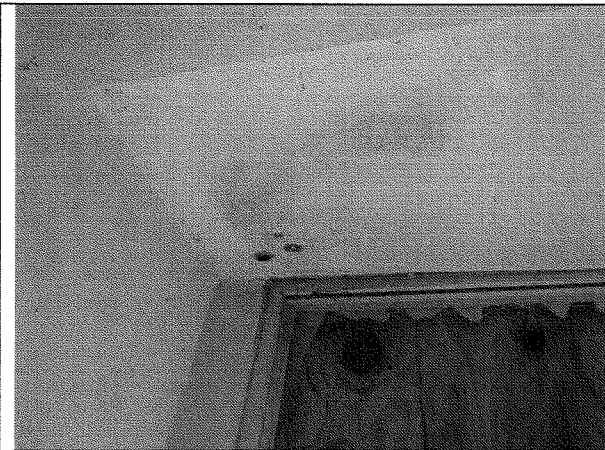
208 First Floor—SE-central room: mold present adjacent to window.

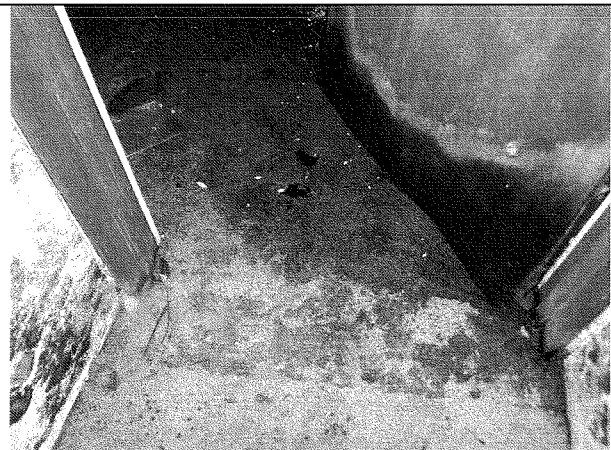
208 First Floor—east room: mold present on walls, flooring, door and door frame. Water present in building materials.

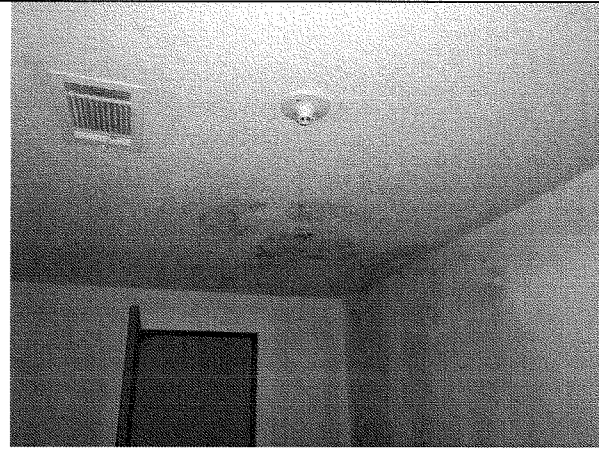
208 First Floor—east room: ceiling and wall mold.

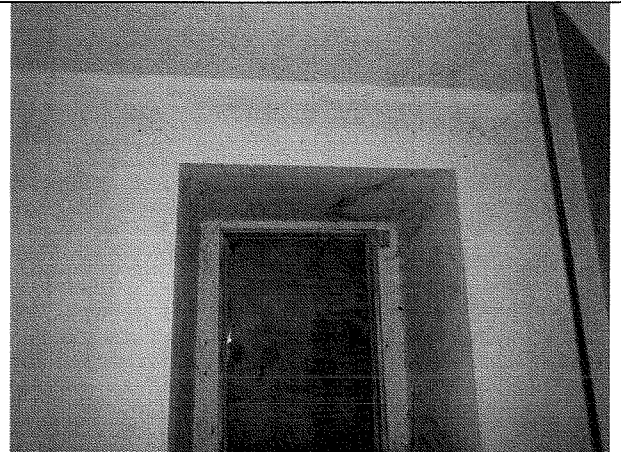
208 First Floor—east room: mold around window area.

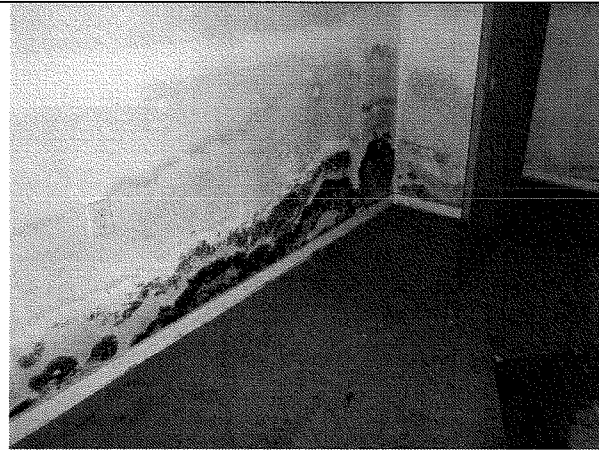
208 First Floor—mold present along lower portion of walls, east room. Floor and wall base were wet at time of visit.

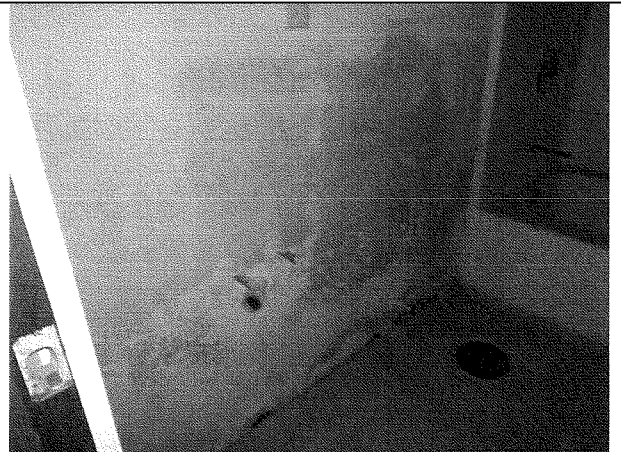
208 First Floor—mold present along bathroom walls.

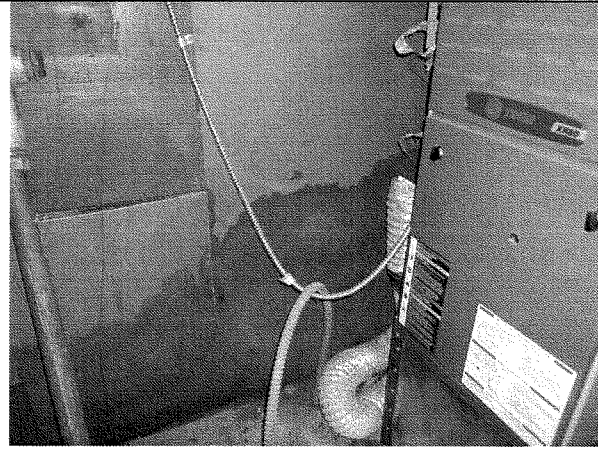
208 First Floor—saturated sheetrock present near furnace in utility room. It was wet at time of visit.

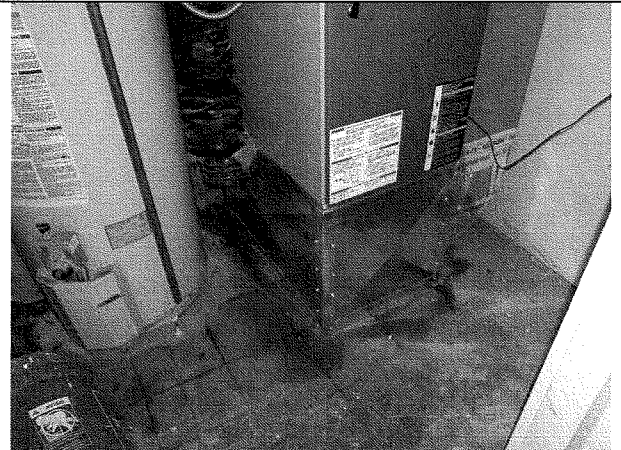
210 First Floor—floor in utility room wet at time of visit.

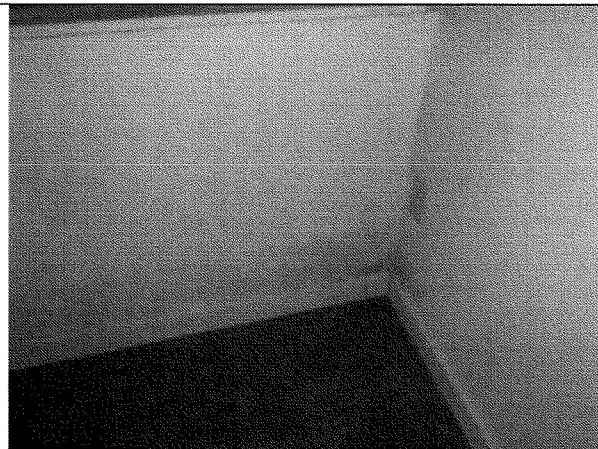
210 First Floor—mold present on the lower portion of the walls in NW-central room.

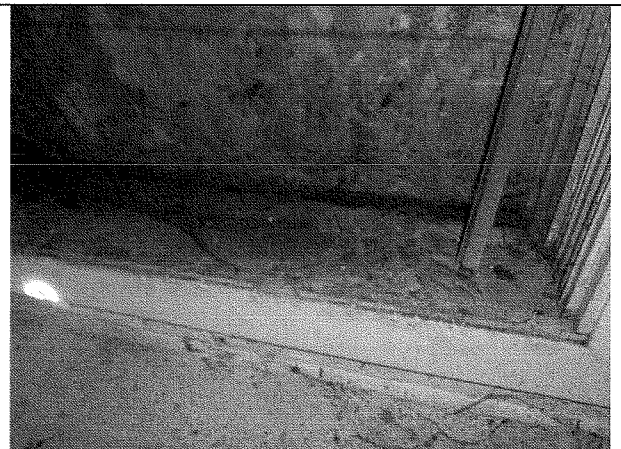
210 First Floor—NW-central room window well: mold

6. Window wells should be inspected to confirm or correct any runoff problems in order to prevent water infiltration.
7. Warning signs should be posted at all access points to the building to warn individuals that mold is present and appropriate personal protection equipment should be used while in the building.

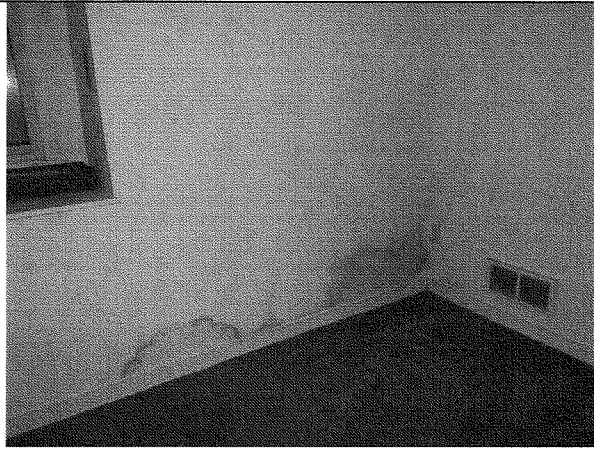
210 First Floor—mold present on the lower portion of the wall NE-central room.

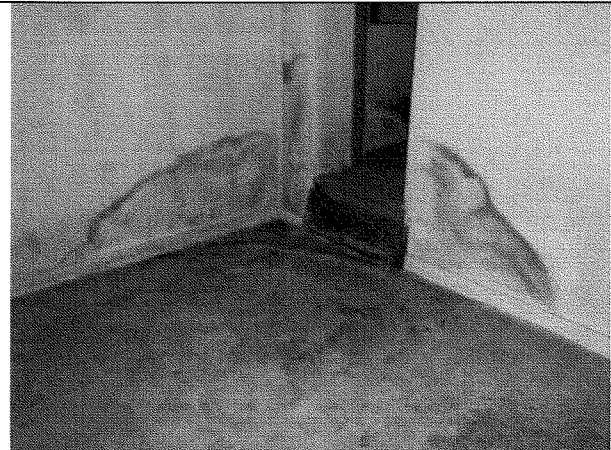
210 First Floor—mold present on the lower and mid portions of the walls in the room off kitchen. Floor was wet at time of visit.

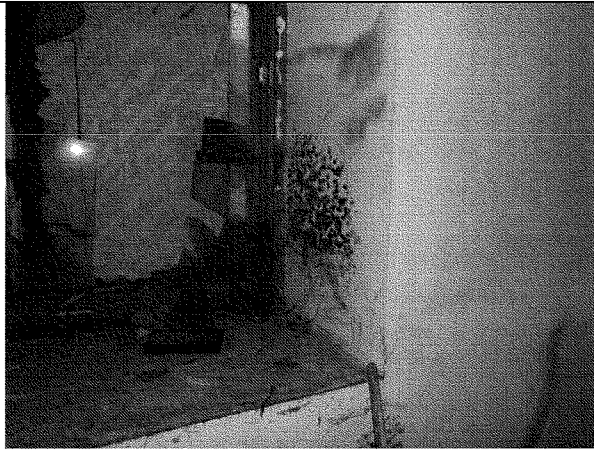
210 First Floor—East room mold present around window.

2. Windows appear to be damaged and/or leaking. The windows should be assessed for damage or integrity problems and repaired or replaced, including appropriate flashing to prevent water infiltration.

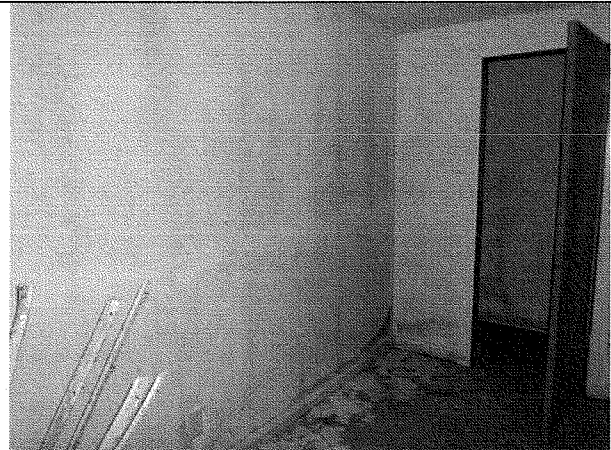
210 First Floor—East room: mold on walls. Note evidence on walls of wet studs. Floor was wet at time of visit.

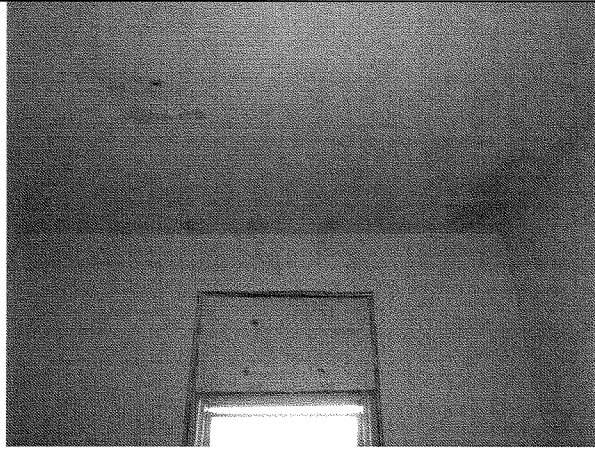
210 2nd Floor—NE-central room. Staining and mold present on ceiling.

1. Roof should be repaired or replaced to prevent water infiltration.

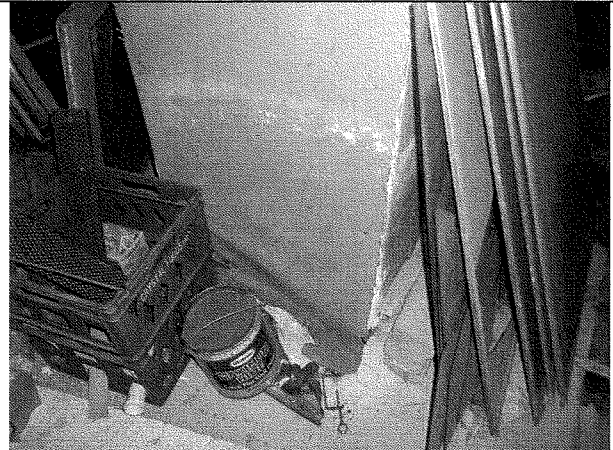
Basement south side—SW area: water damage to sheetrock.

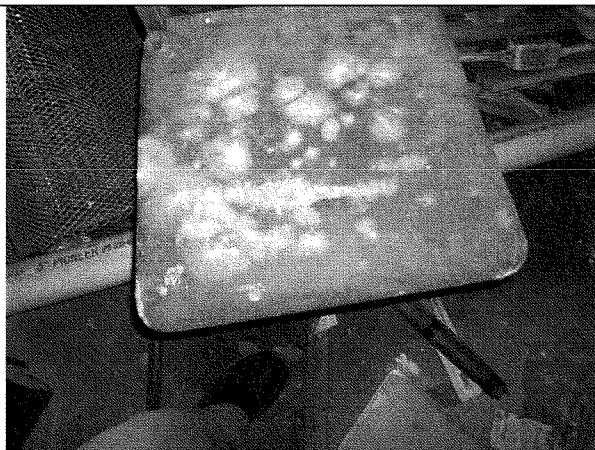
Basement south side—Mold present on table and other materials.

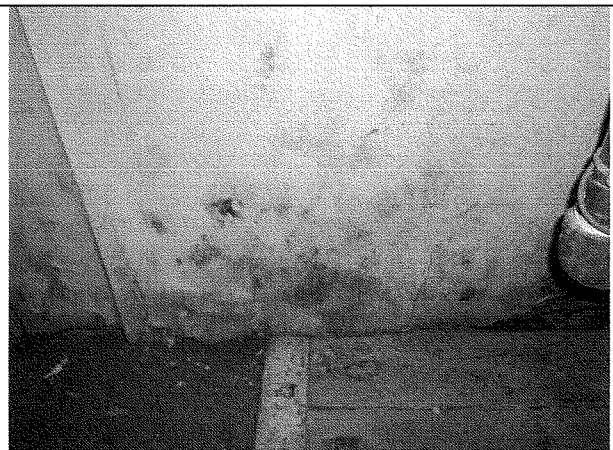
Basement north side—Mold present on the lower and mid portion of the wall as well as water damage to sheetrock.

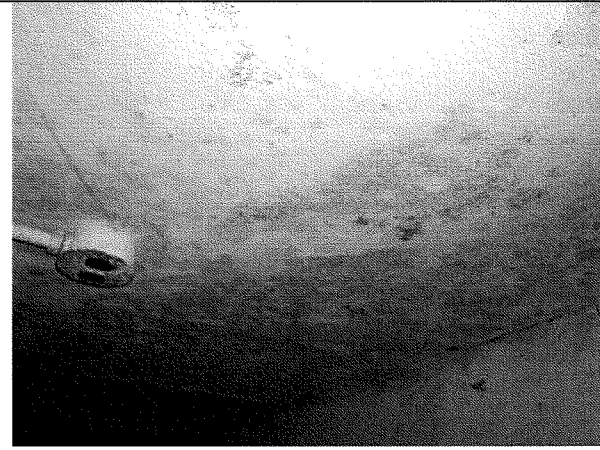
Basement north side—Mold and water damage present on the ceiling sheetrock.

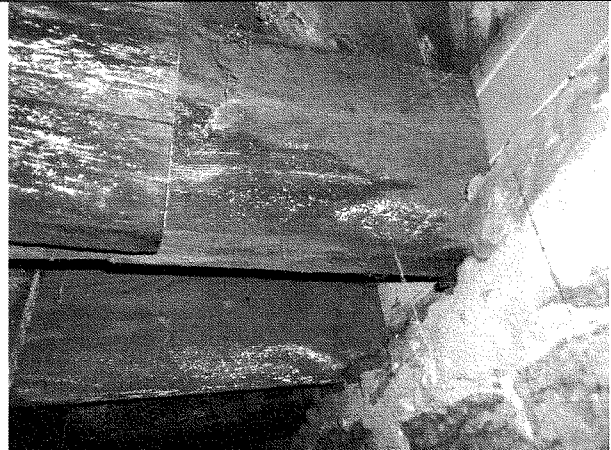
Basement central corridor—mold present on floor joist.

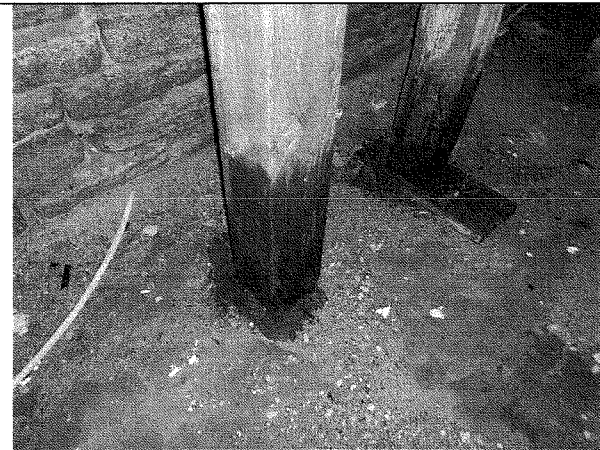
Basement central corridor—water saturated on support beams
